OAKMONT COMMONS – COMMONS DRIVE FLOODING AND DRAINAGE EVALUATION

Oakmont Commons HOA

August 1, 2019

Project Number C-18461-0009

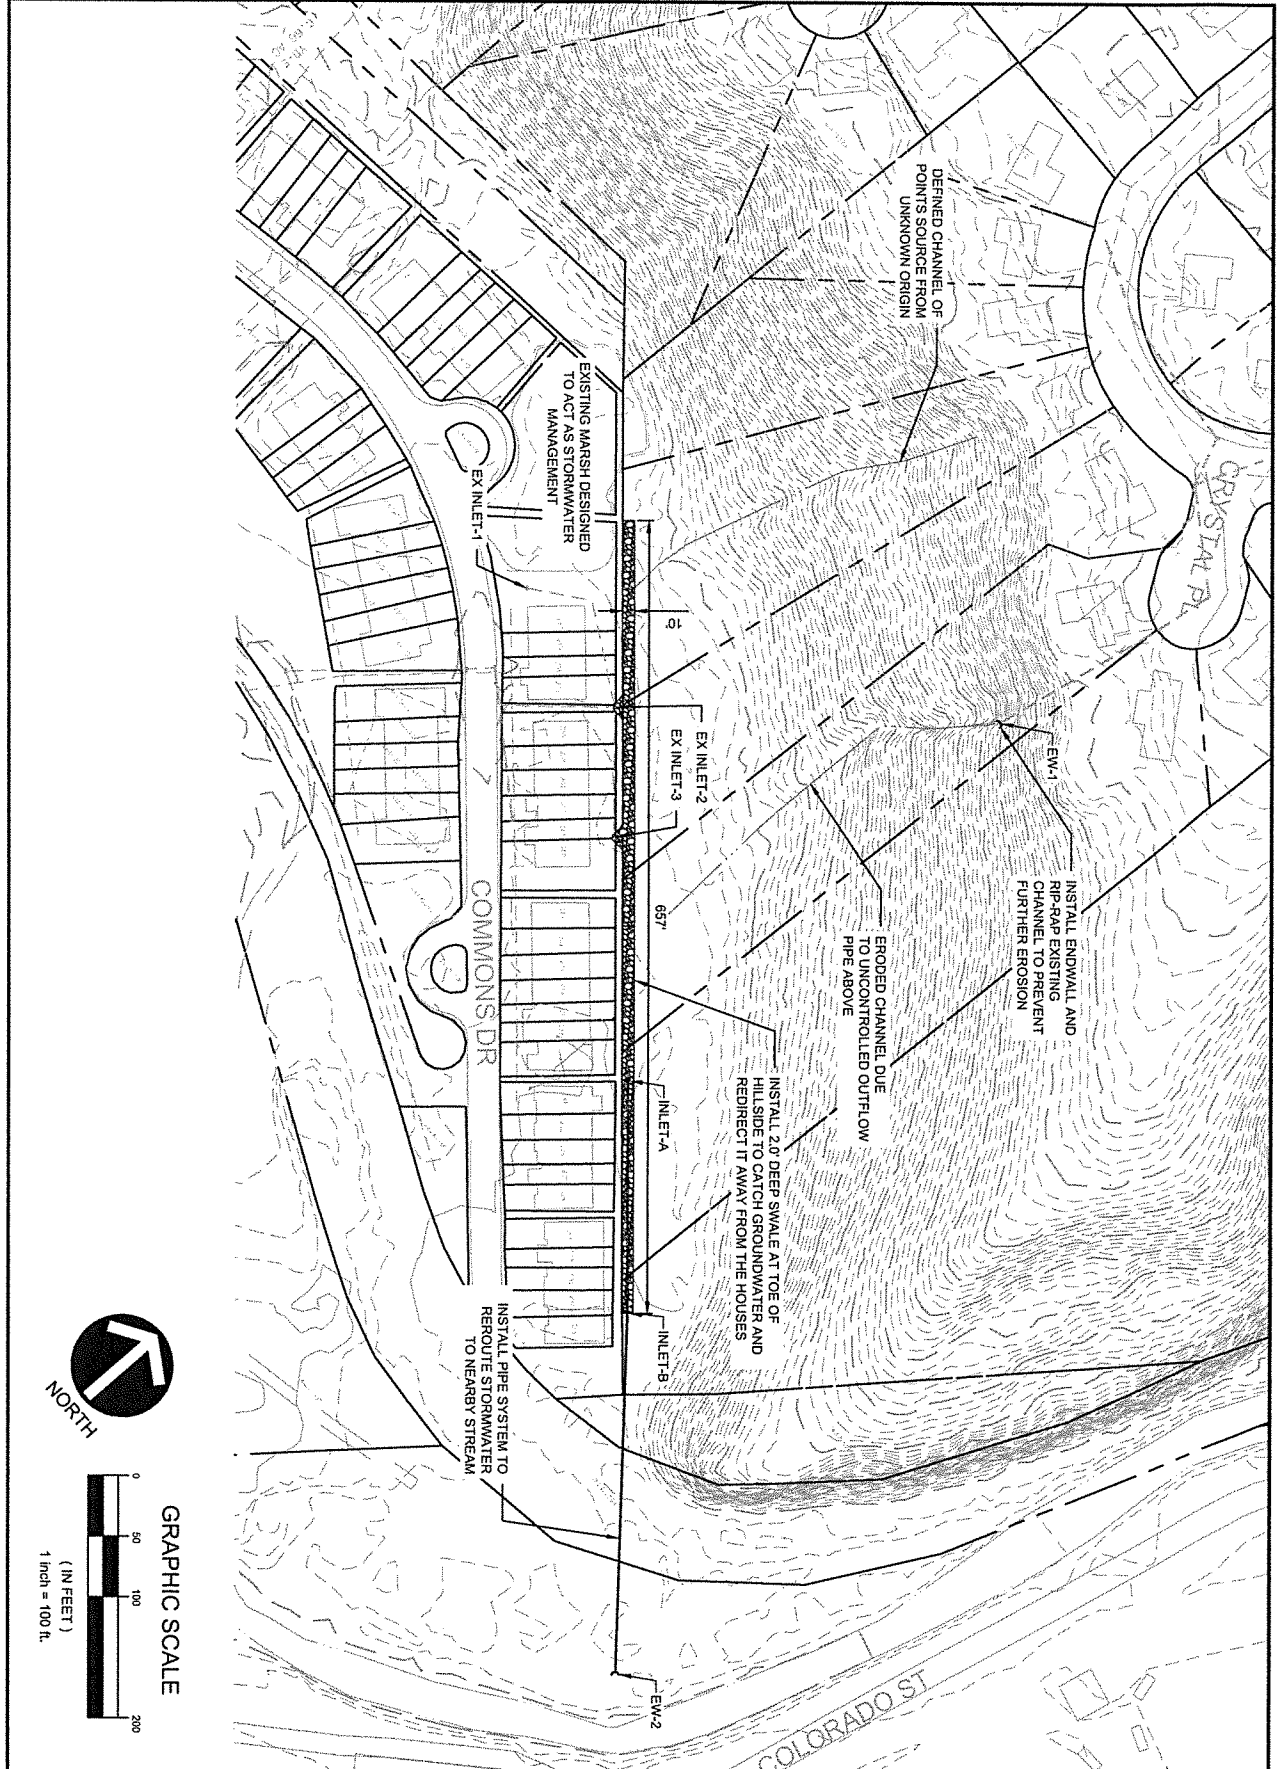
EX-1

During the rain event, water was observed ponding behind the 200 houses and eventually making its way to existing Inlets 2 and 3 shown on the Exhibit by way of surcharging to a level above the existing embankments. The channelized flow from the western channel meandered down the hill and discharged to existing Inlet 1 shown on the Exhibit and not the existing "marsh" area as believed to be originally intended. Over time, the erosion created from the channel appears to have built up in the "marsh" area which can no longer accept water as it appears it was originally intended. Flow from the eastern channel dispersed and began sheet flowing approximately $\frac{3}{4}$ of the way down the hill. The

groundwater sources emerged from the hillside at multiple locations and appeared to accumulate volume as it flowed down the hillside. Large volumes of water were observed at the toe of the slope.

After reviewing the site and the drainage patterns, Gateway is proposing the installation of a rip rap drainage swale along the length of the 200 numbered properties (approximately 660 LF) in order to mitigate both sources of water. Located along the swale will be two additional inlets that will convey water collected by the swale though a pipe system and discharge the water to the creek along the eastern side of the project. Minor grading and modifications to the existing inlets will also create a location for the water collected by the swale to discharge. Gateway also recommends installing a concrete endwall at the discharge points with rip rap in the existing channel to lessen erosion and reduce the velocity of the flow from the point sources. We determined this recommendation to be the most feasible due to the lack of any one single source of water. From the site visit, the two point sources appear to be the main contributor to the flow volume; however all flow must be captured to mitigate the damage.

Attached is an exhibit depicting the approximate locations of the proposed drainage swale and pipe system. Also attached is the pipe sizing calculations used to determine the proposed system pipe sizes.
